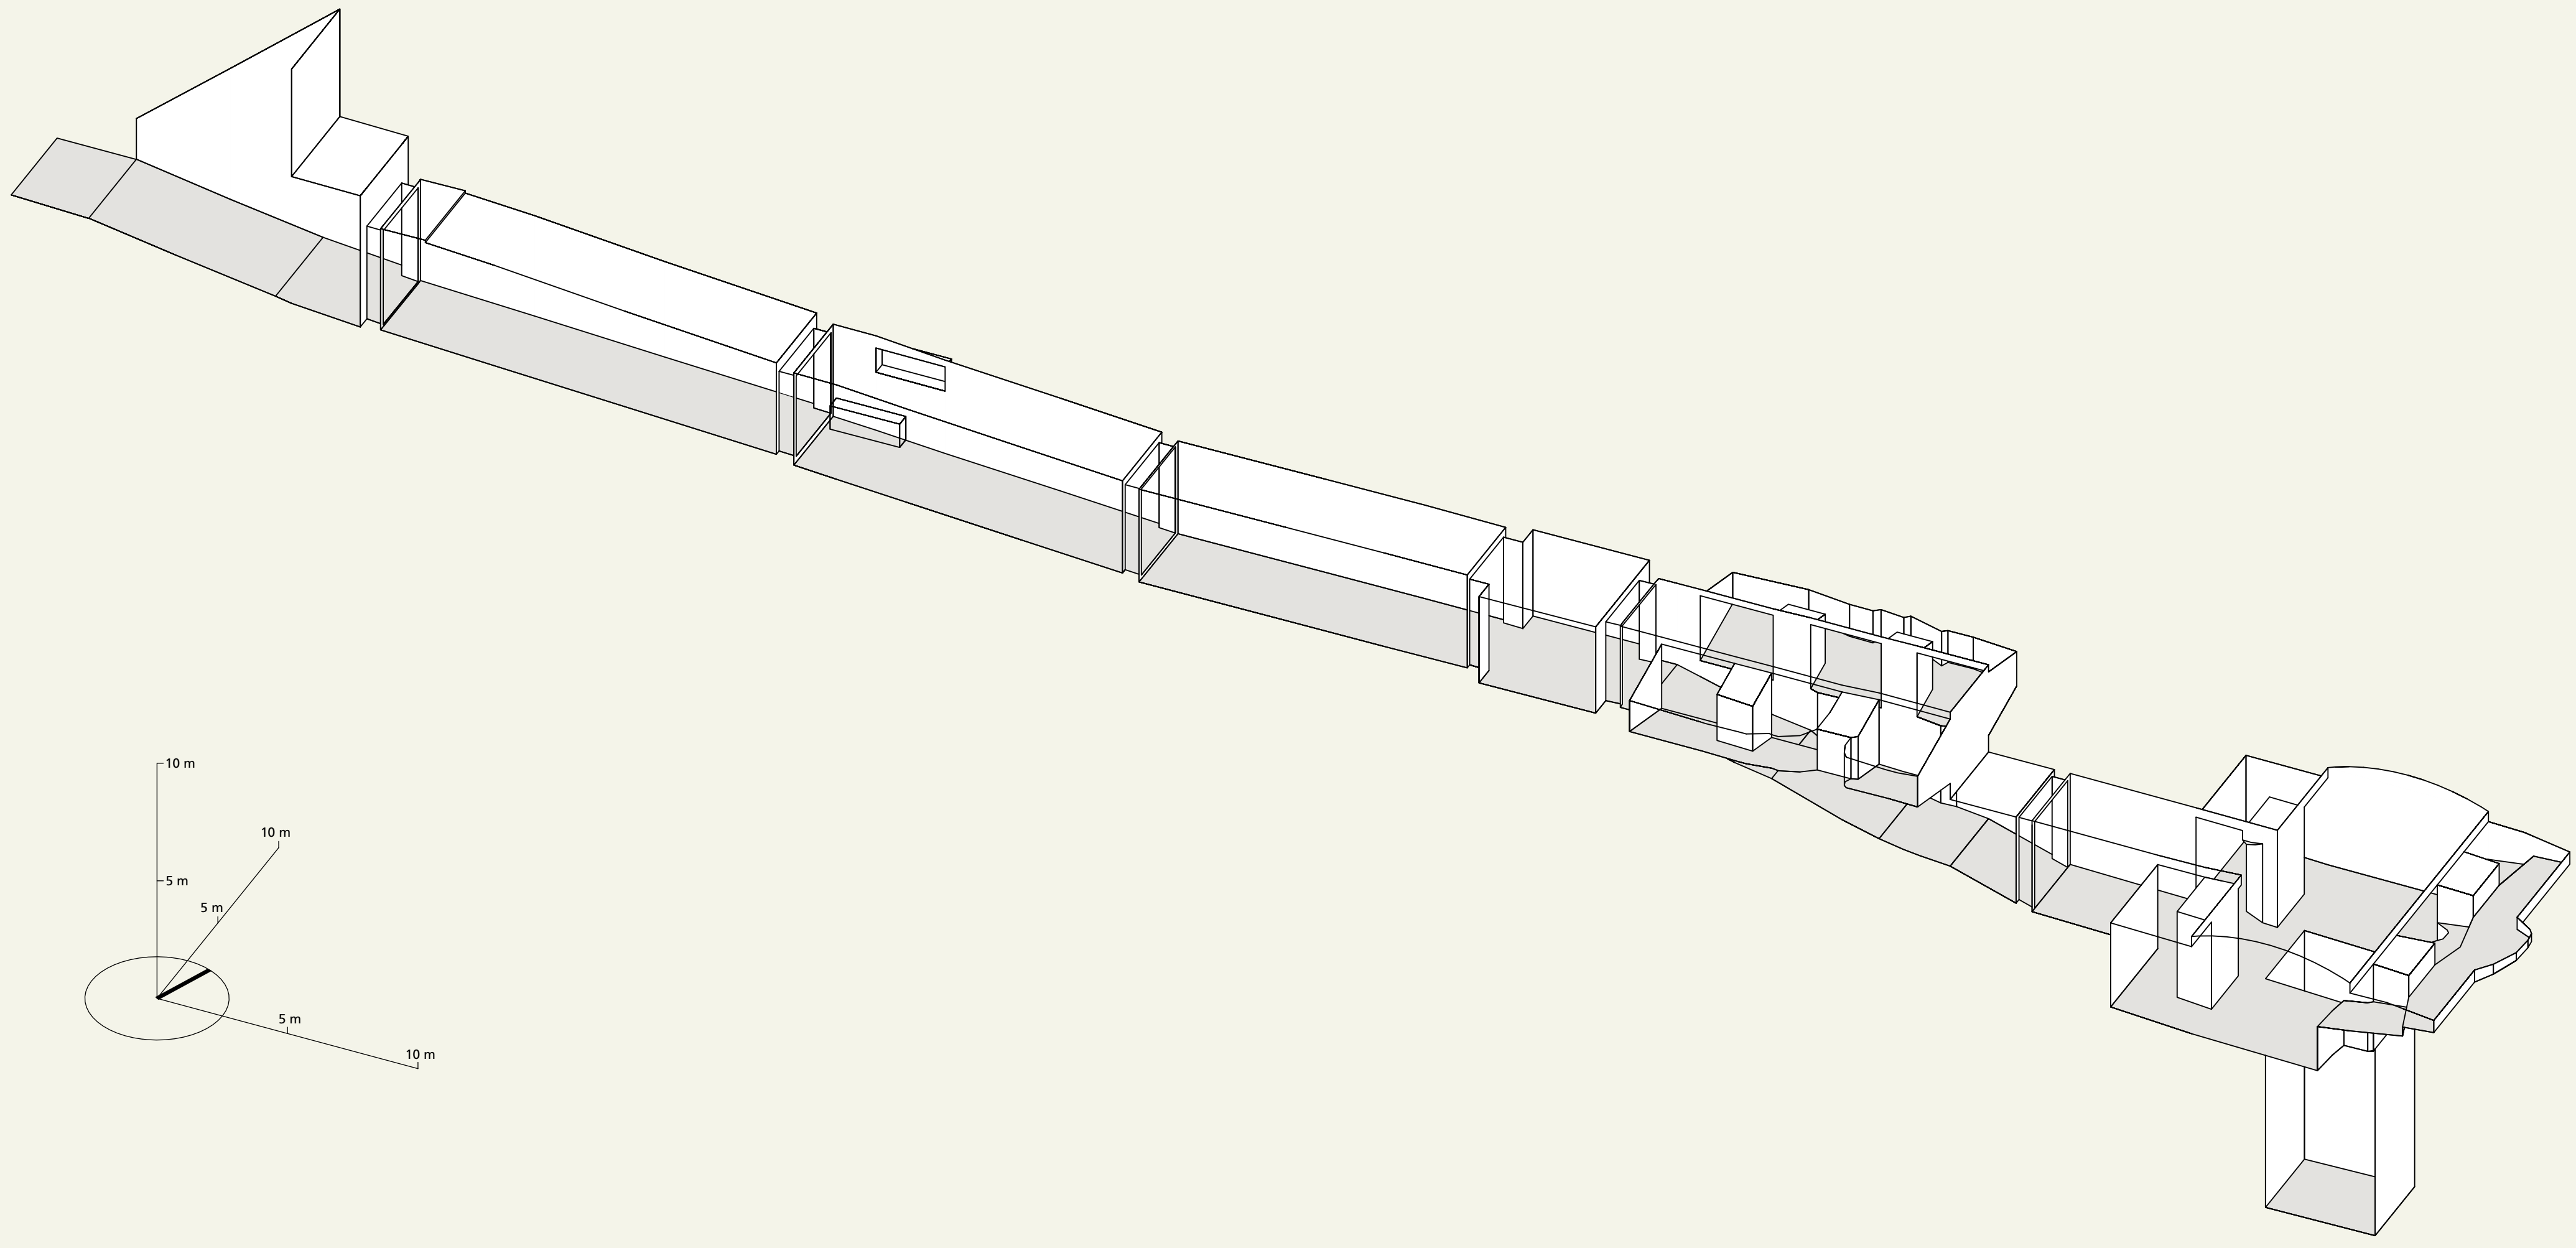
NOTES	
1	Socket for wooden beam that supported the fractured section of the overhang. The beam and the section have fallen away.
