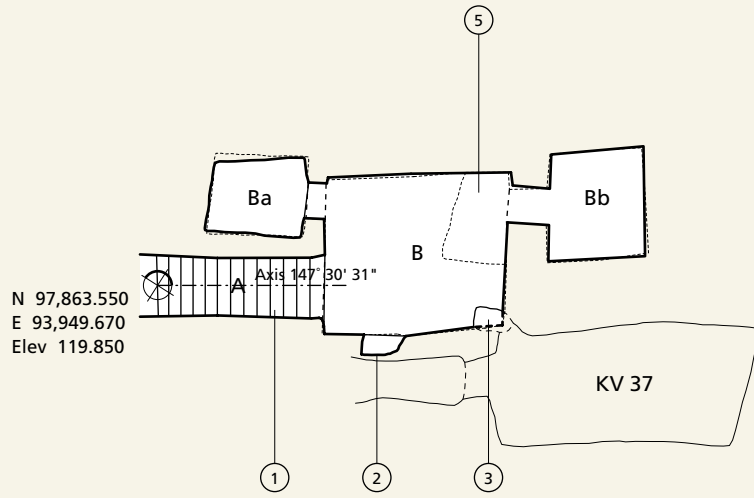
NOTES	
1	Modern steps.
2	Unfinished cutting breaks into entryway of QV 37.
3	Break into QV37 filled with rubble.
4	Ceiling generally damaged.
5	Area of well-preserved ceiling above.
6	Badly damaged ceiling.
7	Approximate line of original ceiling.
