CHAPTER FIVE KV CONDITION SURVEYS

5.2 Current Tomb Condition Report⁴

5.3 Tomb Environmental Monitoring

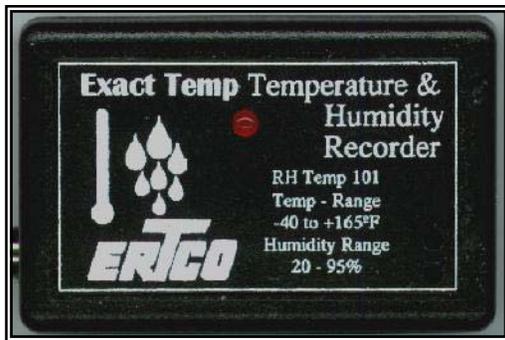
Figure 55: ERTCO Data Logger

The data loggers we used are from the Ever Ready Thermometer Company Inc (ERTCO), the RHTEMP101 is a miniature, battery-powered, stand-alone, temperature and humidity recorder (Figure 55). This device combines the latest in low power technology with Windows-based software to provide a Temperature and Humidity Recorder. Its real-time clock enables all data to be time and date stamped.

Its reading rate is user-selectable and can range from one every two seconds to one per day. The start time and calibration are both programmable, as well as having the capability of alarming and real time monitoring. Once activated, the device measures and records 4,096 humidity and 4,096 temperature measurements simultaneously. The storage medium is non-volatile solid-state memory, providing maximum data security even if the battery becomes discharged. It is small enough to be unobtrusive nearly anywhere. Once the data is collected, retrieval is simple. The software enables users to select reading rate, device i.d., and initiate the start of data collection within moments after hardware is connected.

- Calibrated Accuracy: $\pm 0.5^{\circ}\text{C}$ (0 to $+50^{\circ}\text{C}$)
- Temperature Resolution: 0.1°C
- Temperature Range: -40°C to $+80^{\circ}\text{C}$.
- Humidity Accuracy: 2% RH
- Humidity Resolution: 0.5% RH
- Humidity Range: 5 to 100% RH
- Operating Environment: -40°C to 80°C , 5 to 95% RH
