QV 11
 N 97,970.875
 E 93,998.448
 Elev 109.603
 Axis 173° 23' 44"

QV 12
 N 97,966.454
 E 93,993.768
 Elev 110.995
 Axis 173° 23' 44"

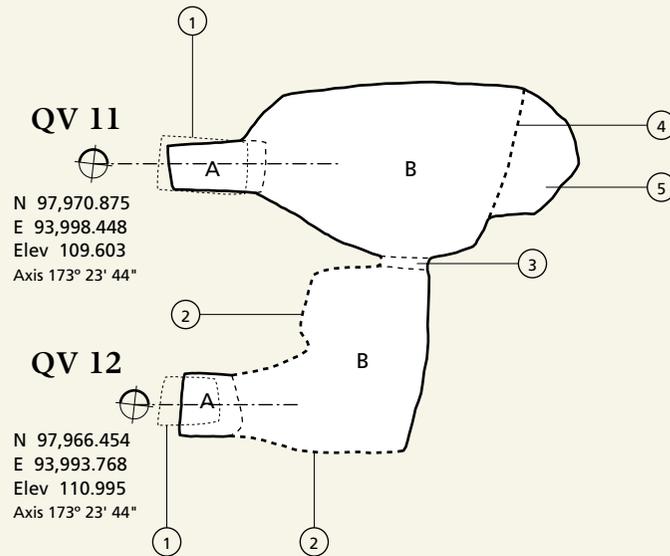
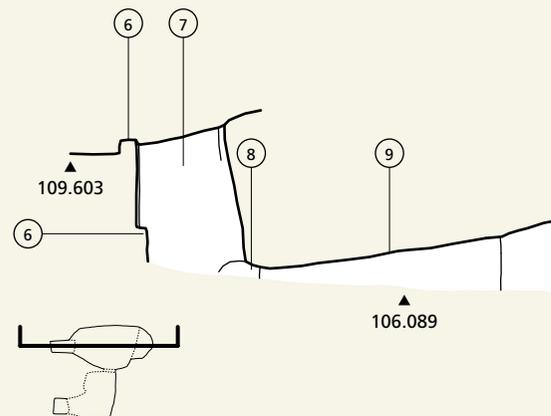
NOTES	
1	Top of pit.
2	Dimensions of wall approximate.
3	Size, location of opening approximate.
4	Possibly the original line of back wall.
5	Ceiling collapsed at rear of chamber.
6	Rough stone retaining wall.
7	Dimensions of shaft approximate.
8	Dimensions of doorway approximate.
9	Dimensions of ceiling approximate.

Survey notes incomplete, section of QV 12 could not be resolved.
