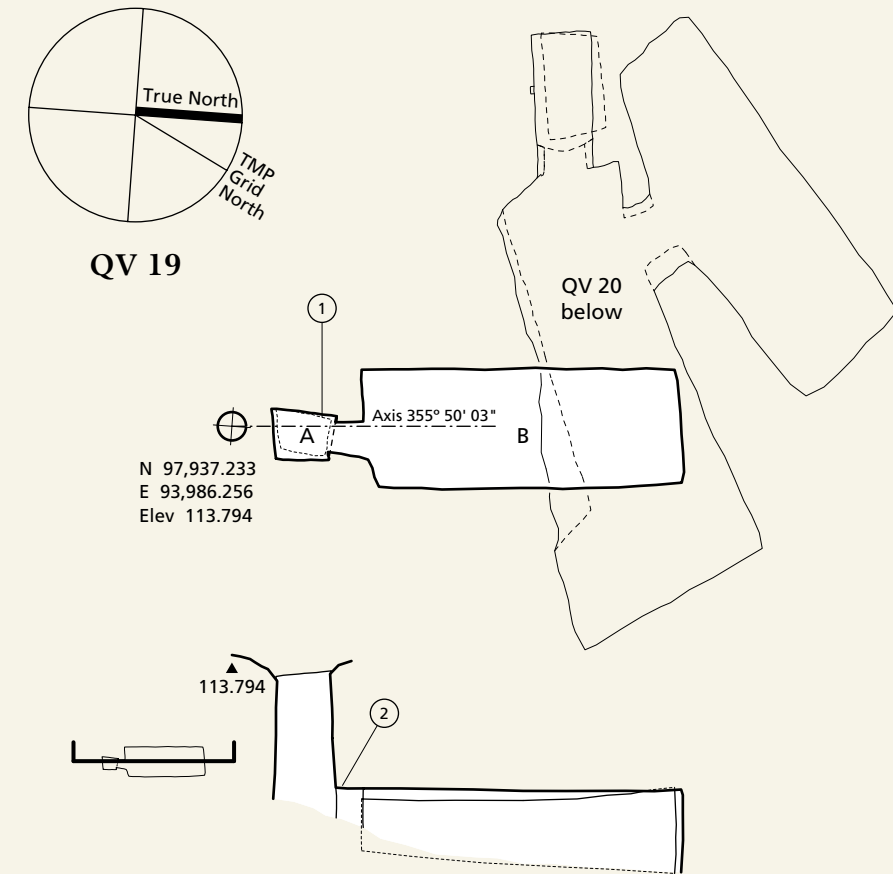
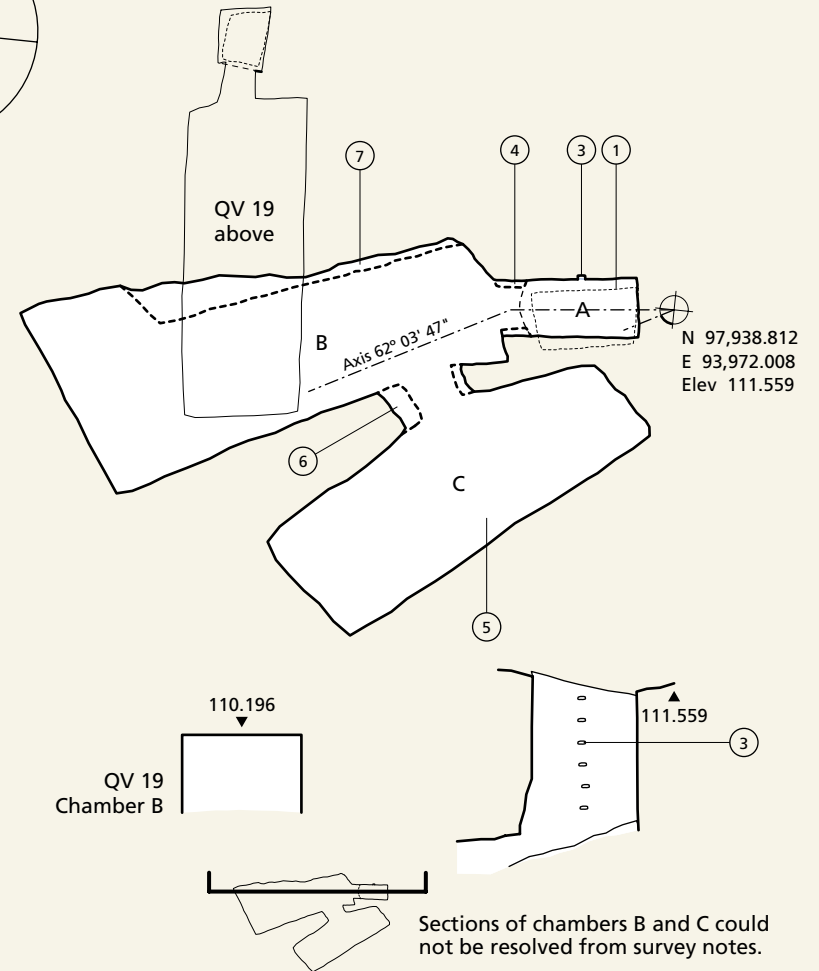
NOTES	
1	Top of pit.
2	Lintel broken; measurements uncertain.
3	Series of six hand-holds cuts into side of pit shaft; dimensions and locations approximate.
4	Doorway badly damaged; no signs of jambs remain.
5	Ceiling collapsed in center of chamber C.
6	Doorway badly damaged; original jambs estimated.
7	Entire section of wall collapsed; signs of original wall remain at ceiling.
