QV 23

QV 25

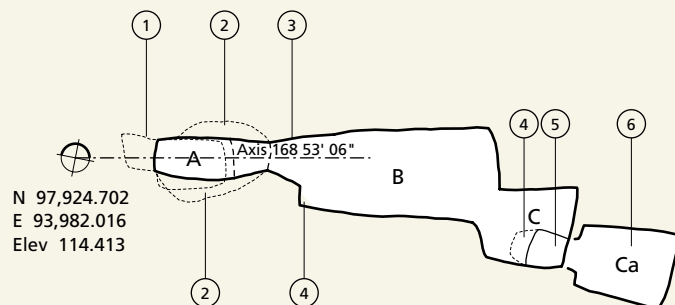
NOTES	
1	Top of pit.
2	Poor stone; sides of original pit shaft broken.
3	Shape of wall is uncertain.
4	Rear niche in pit.
5	Pit shaft in floor of chamber C.
6	Pit chamber filled with mummies; dimensions of chamber approximate.
7	Floor covered in debris.
8	Small break into QV 24.
9	Details of entry uncertain.
