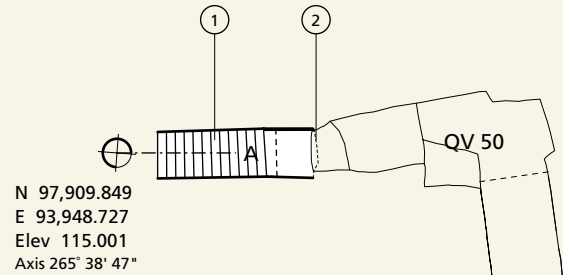
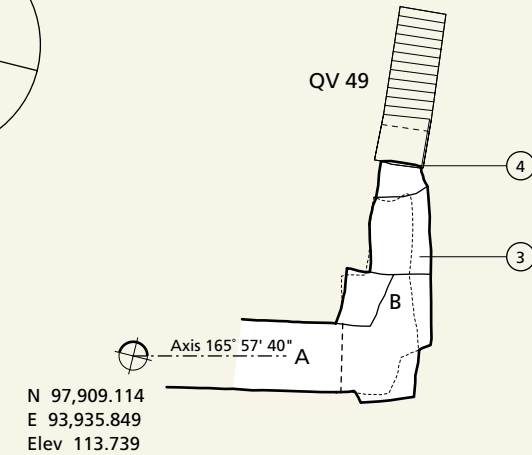
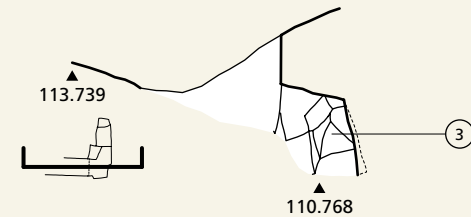
NOTES	
1	Dimensions of stairway approximate.
2	Tomb unfinished or filled with debris; possibly breaks into QV 50.
3	Chamber B unfinished, cut to different levels along stratum lines.
4	End of chamber B possibly breaks into QV 49.
