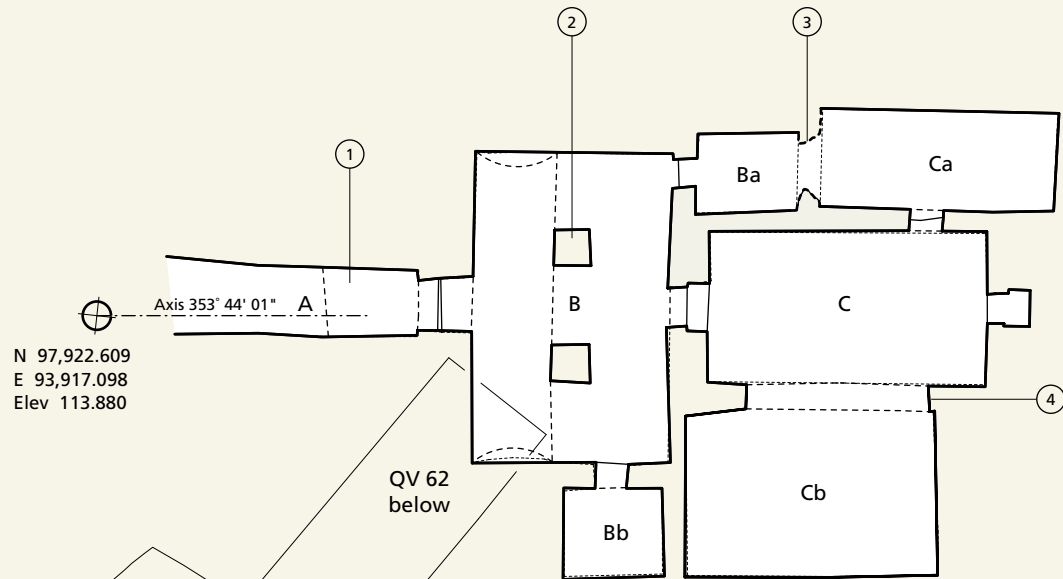
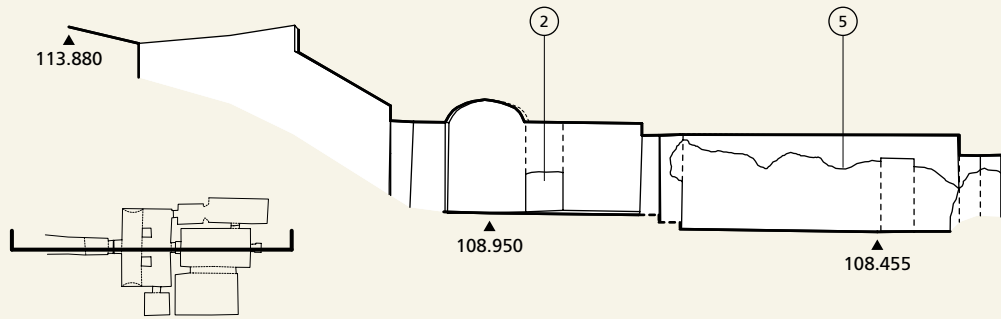
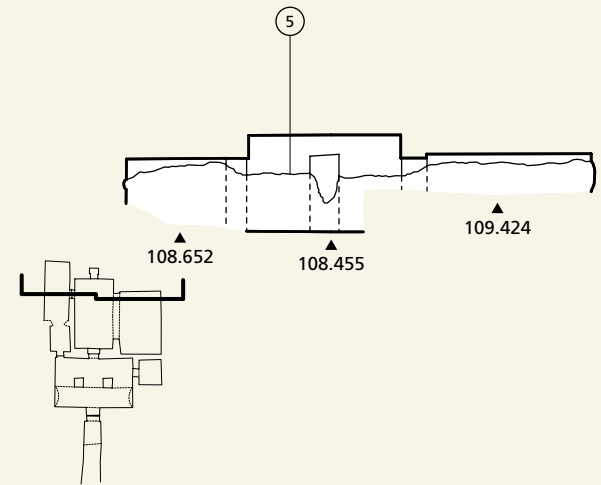
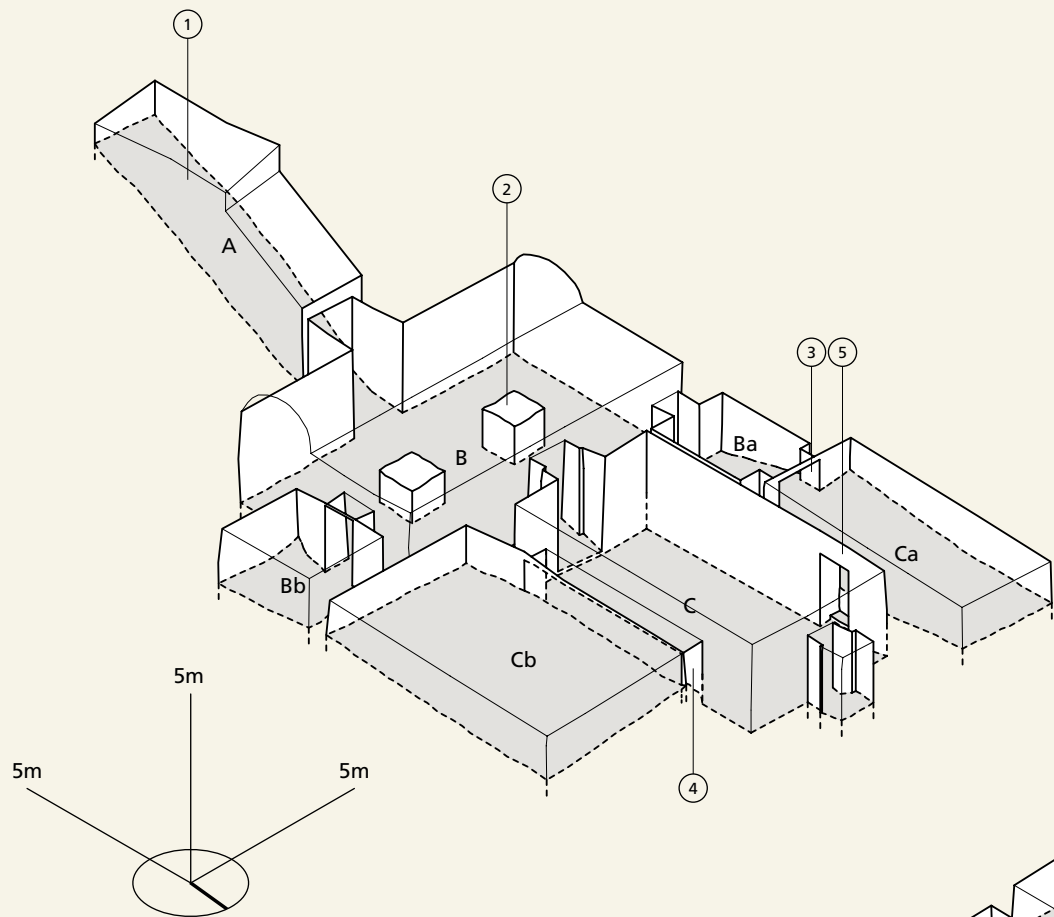
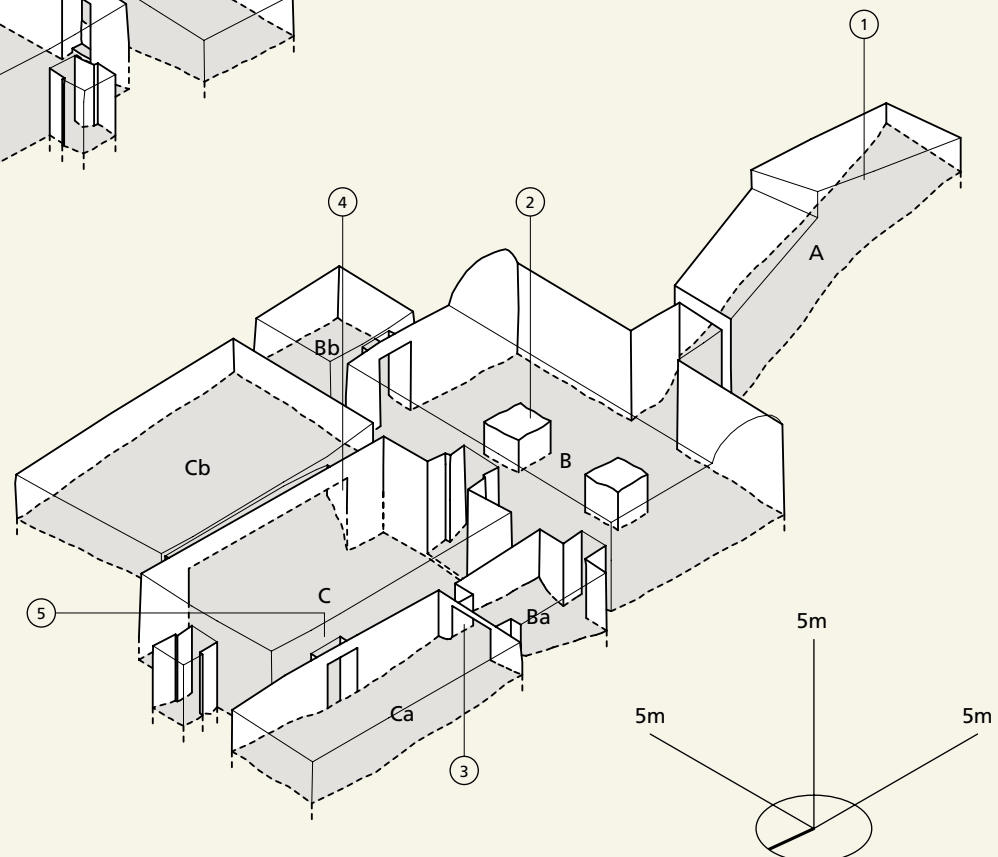
NOTES	
1	Entry filled with debris; original stairs or ramp not visible.
2	Top portion of pillars destroyed.
3	Jambes at either end are badly damaged.
4	Jambes at either end are badly damaged but may be parts of two doors piercing the wall between chambers C and Cb.
5	Bottom portion of walls and gates destroyed.

Due to the severely damaged condition of the tomb, the location and existence of walls, doorways, and pillars are largely speculative.
