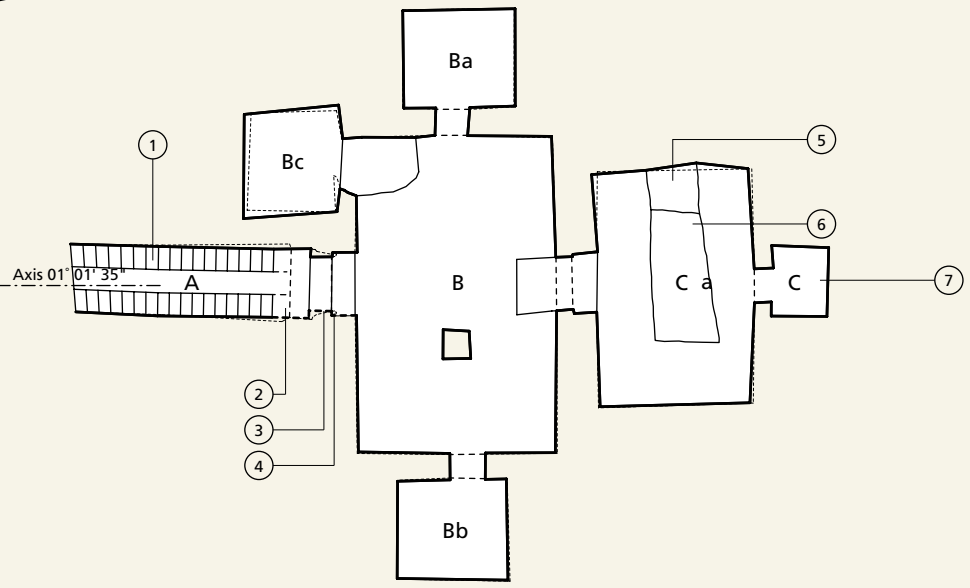
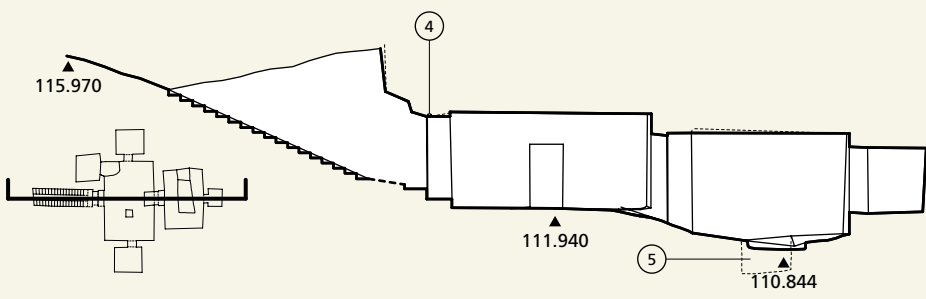
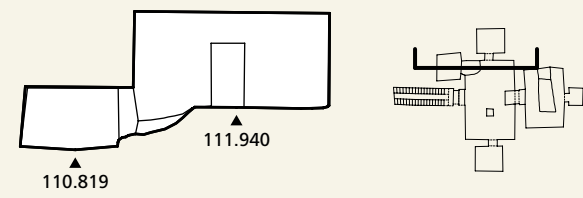
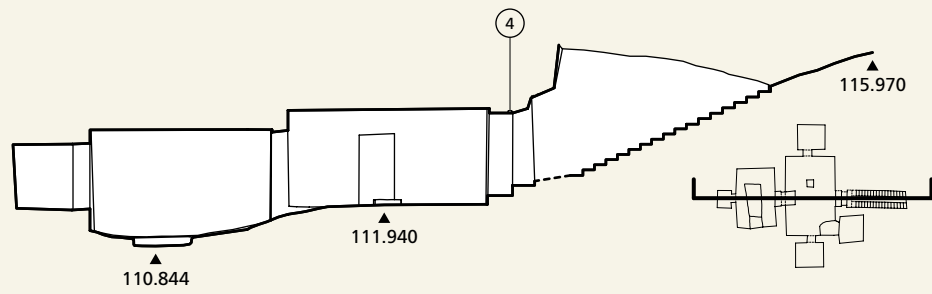
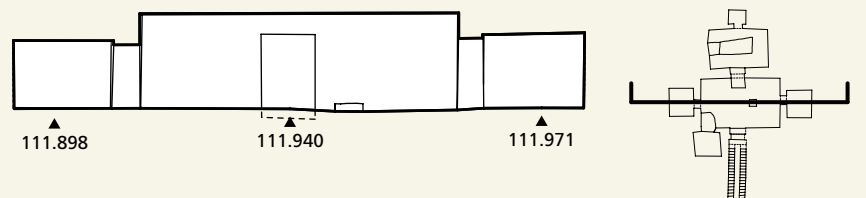
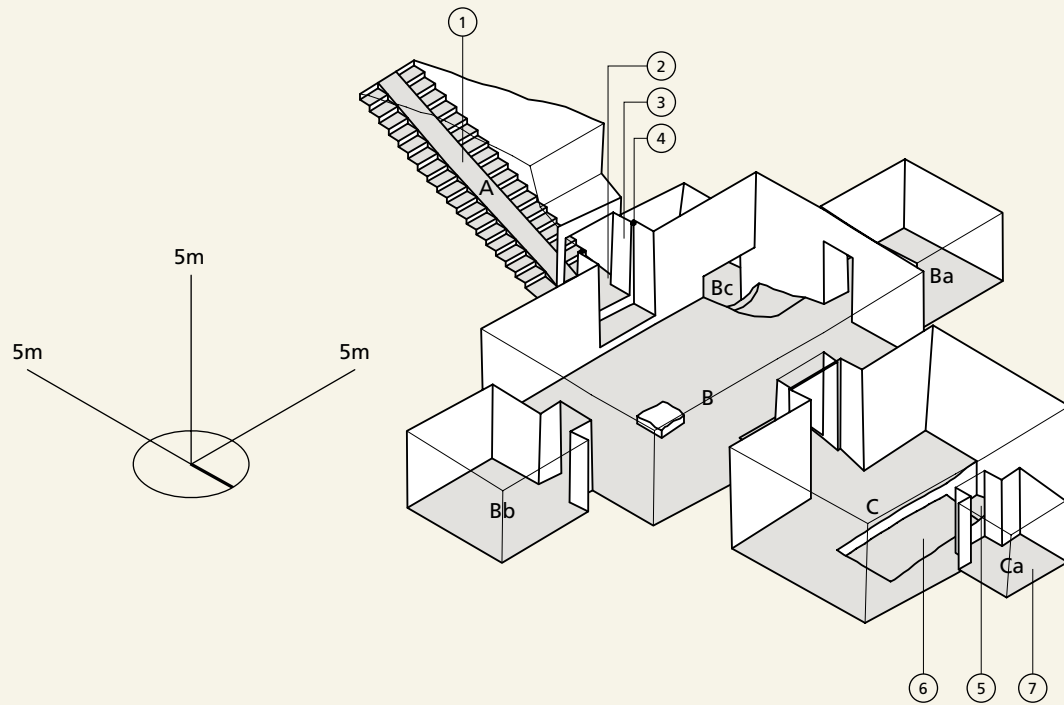
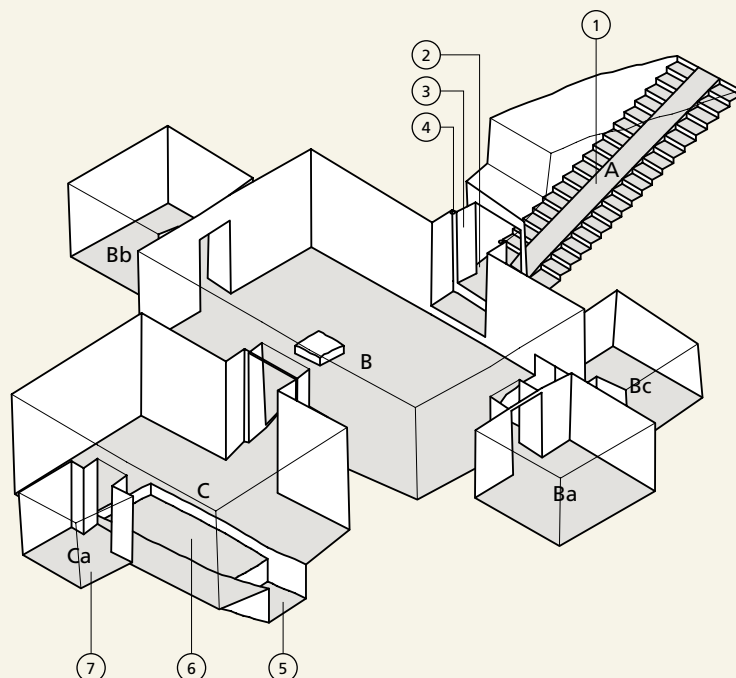
1	Width of steps and central ramp approximate.
2	Floor covered with debris; unclear if steps or ramp lie below.
3	Floor covered with debris; dimensions of door jamb approximate.
4	Door post holes in ceiling on both sides.
5	Pit 0.90m deep; possibly intrusive (i.e. later than original pit).
6	Pit 0.30m deep; this is likely the original pit.
7	Dimensions of Ca approximate.
