Wadi D-1 - Menhet, Menwi & Merti, Dyn. XVIII  
Plan, sections

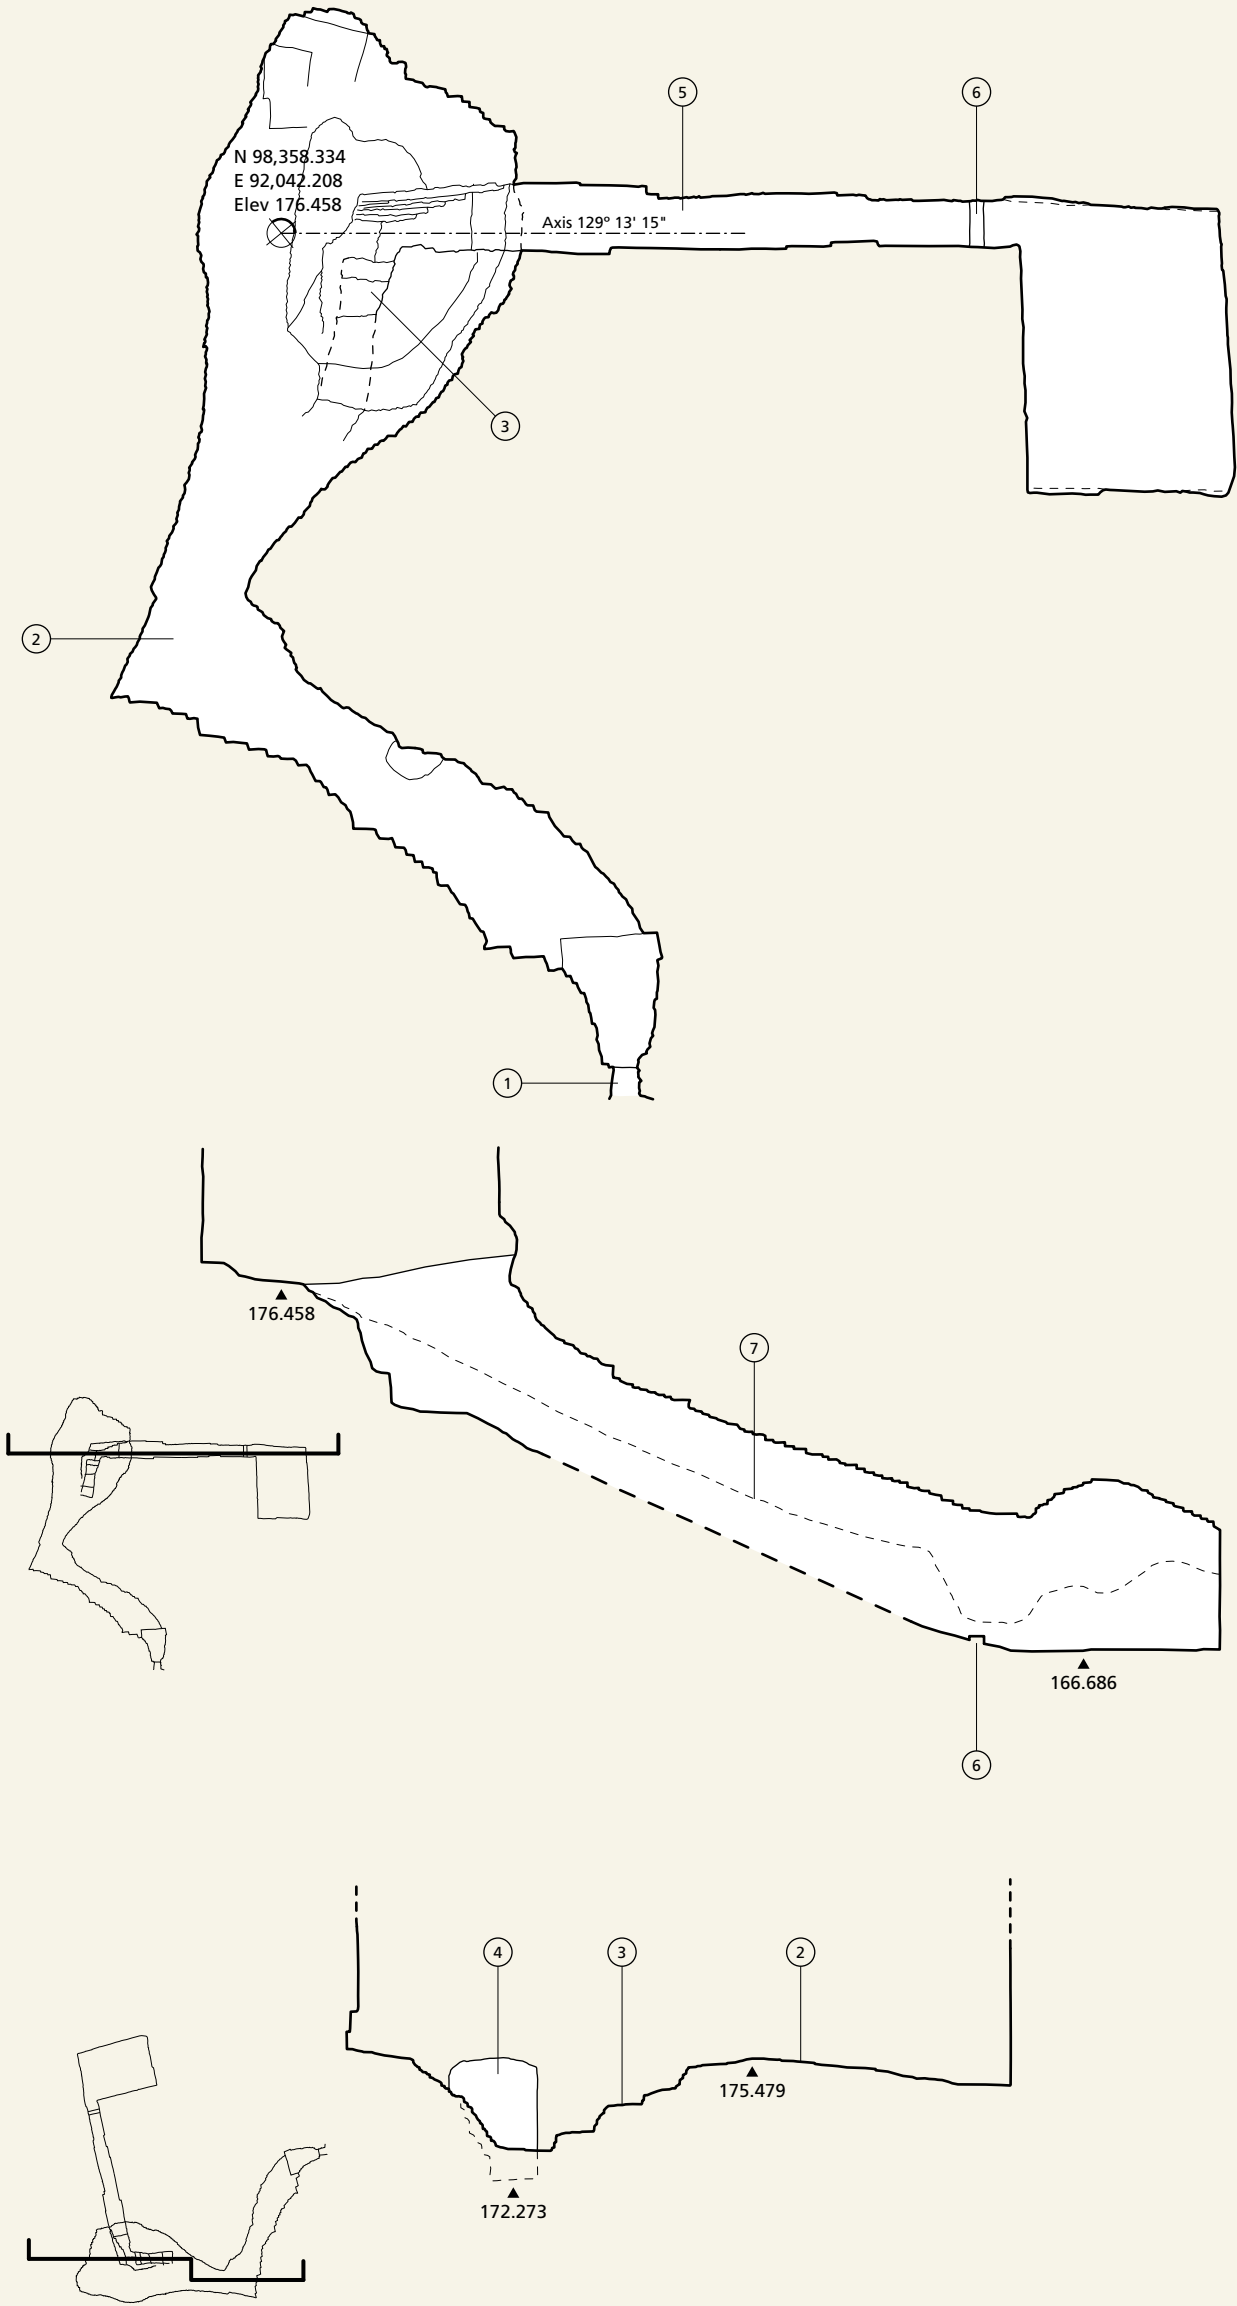
NOTES	
1	Entrance to crevice in cliff.
2	Platform inside crevice.
3	Poorly-cut steps.
4	Doorway.
5	Interior of tomb not surveyed by TMP due to resident snake.
6	"Sill" in floor.
7	Level of debris as found prior to clearance by Lilyquist.
