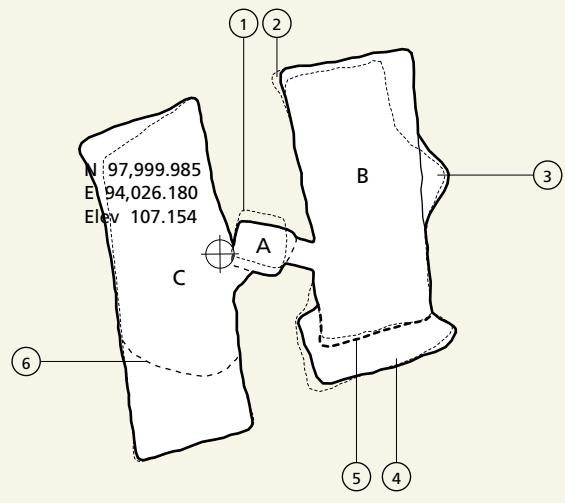
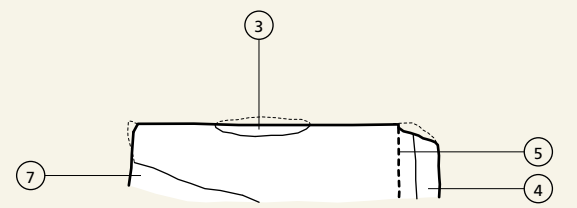
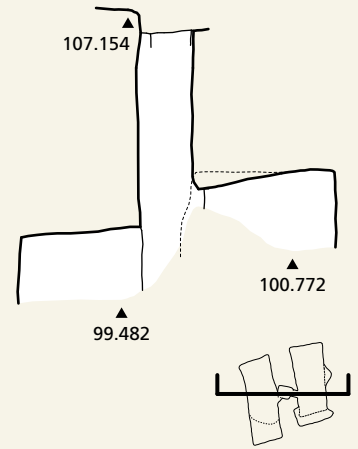
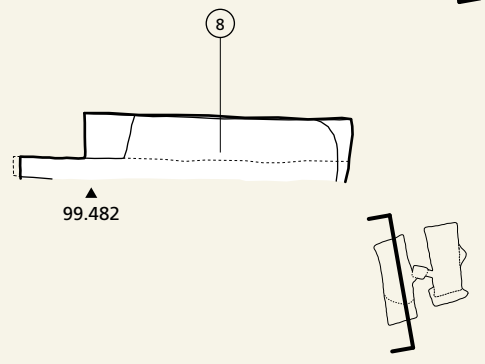
NOTES	
1	Top of pit.
2	Corner bulges outward halfway between floor and ceiling
3	Break in wall; dimensions approximate.
4	Walls and ceilings collapsed in this section.
5	Line of original walls (corners visible at ceiling).
6	Change in ceiling height.
7	Unexcavated rubble.
8	Stratum of hard stone overlays stratum of soft stone in chamber C.
