**QV 9, QV 10 - Anonymous, Dyn. XVIII**  
Plans, sections

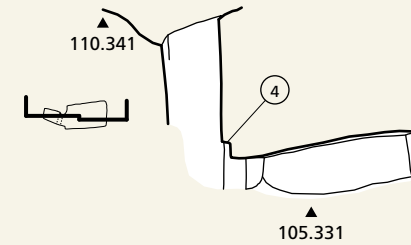
NOTES	
1	Top of pit.
2	Shape of chamber is approximate: sketch shows rubble sloping down towards back of chamber and the ceiling relatively flat, but survey notes show both rubble and ceiling sloping upwards.
3	Uncertain if jamb exists.
4	Shape of lintel is uncertain.
