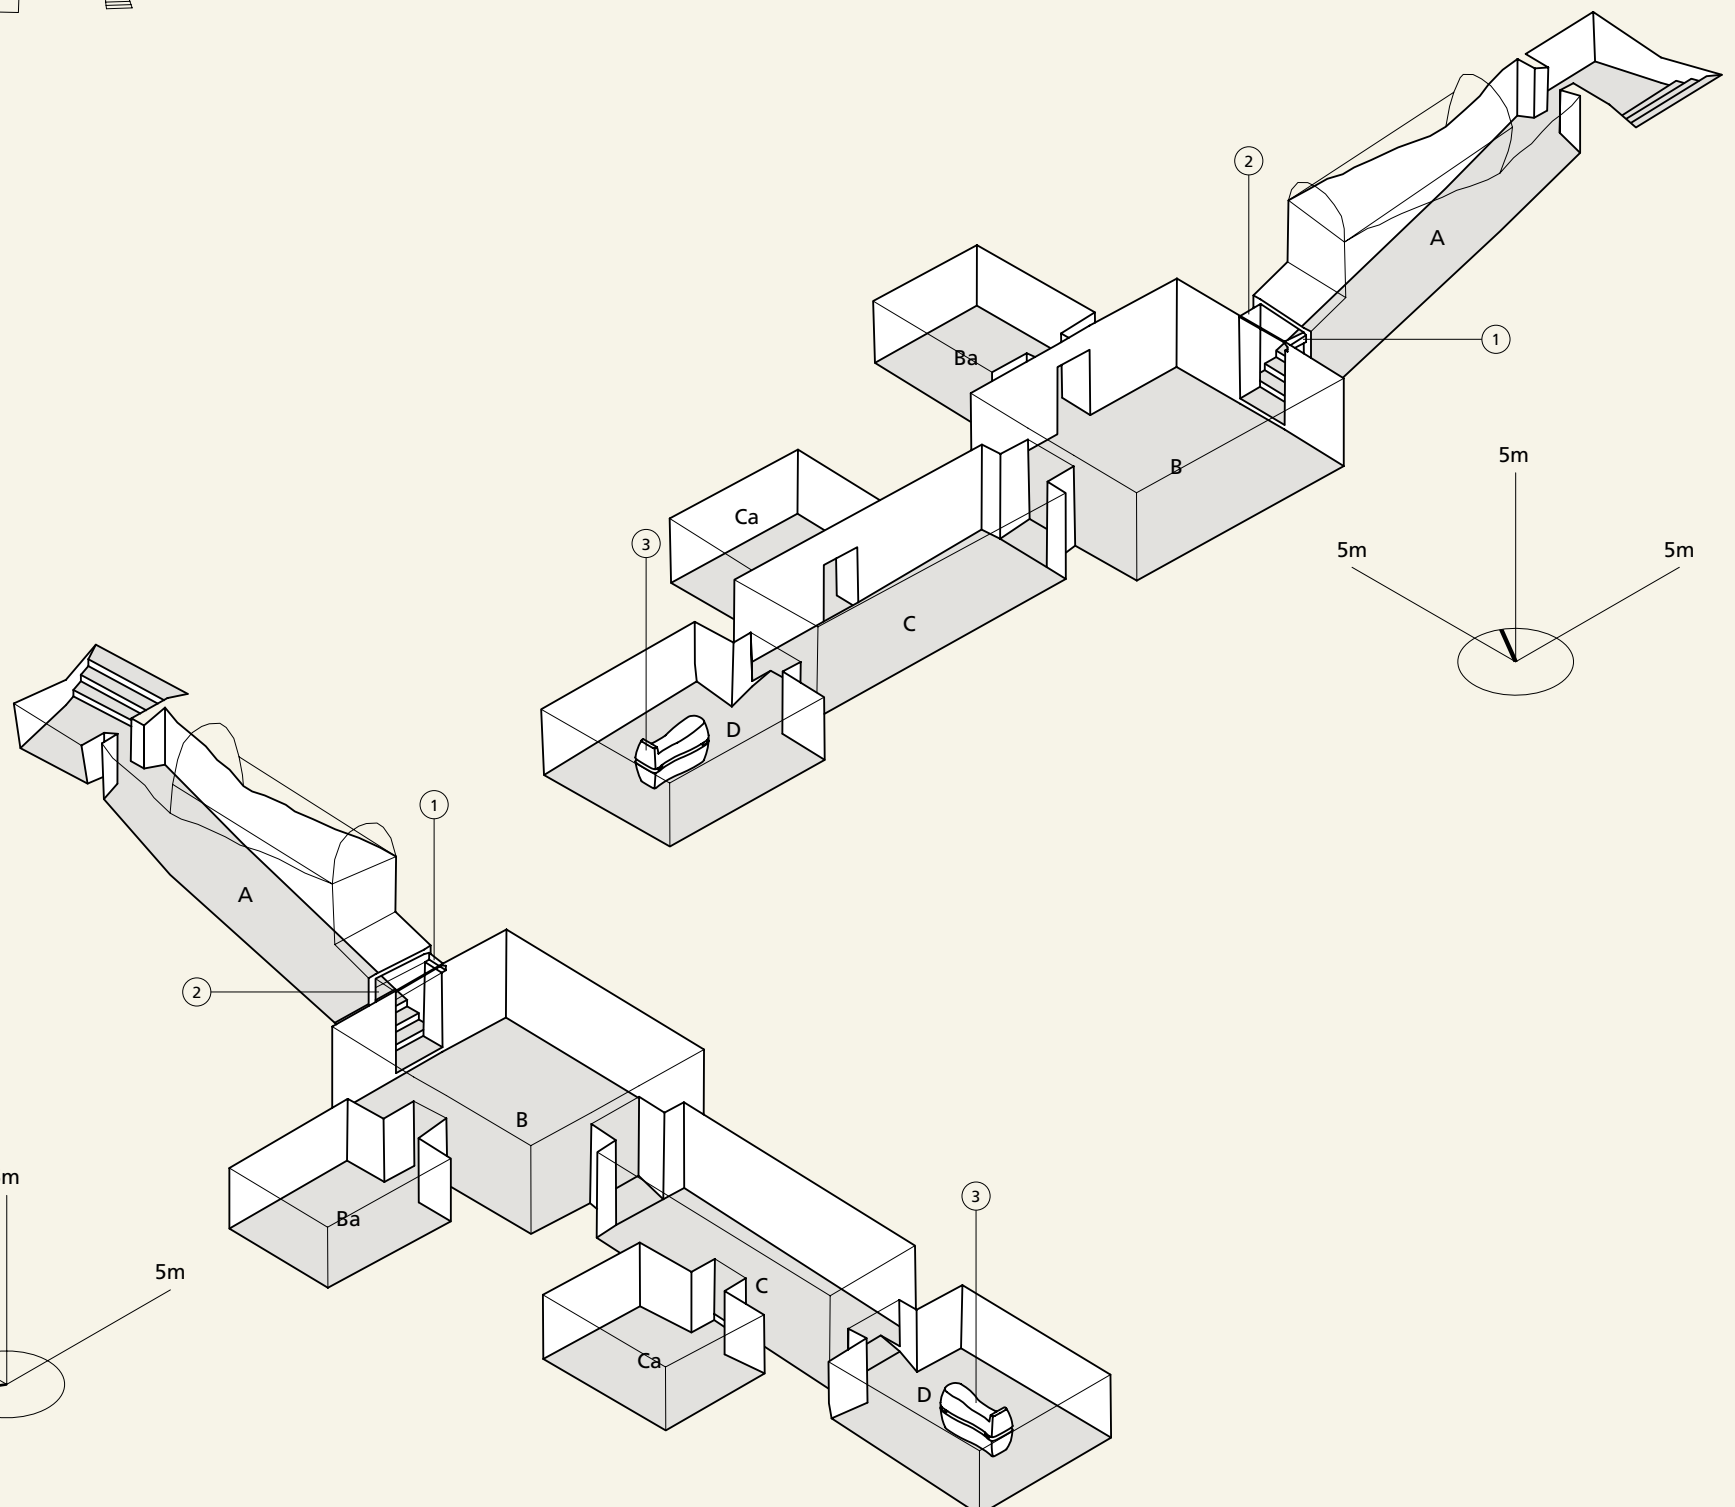
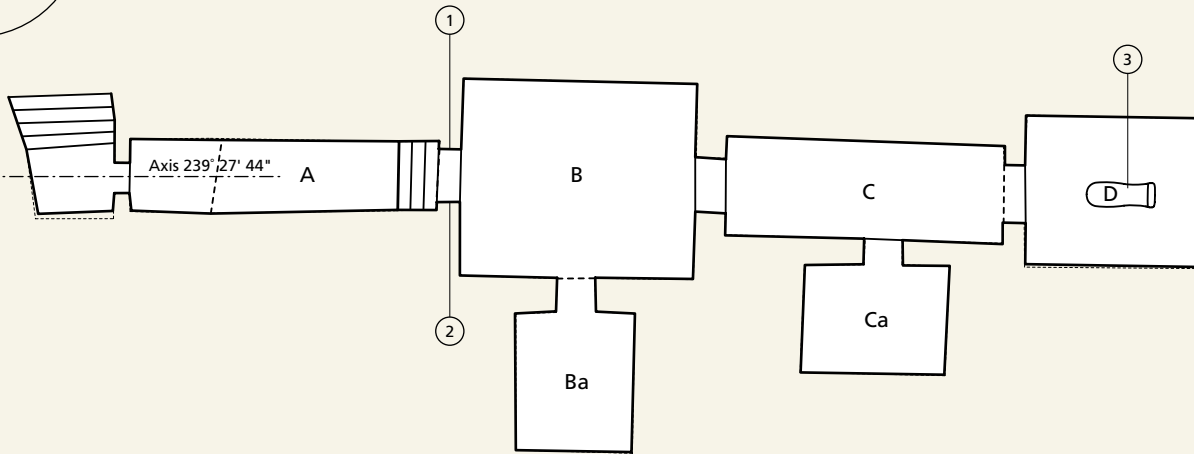
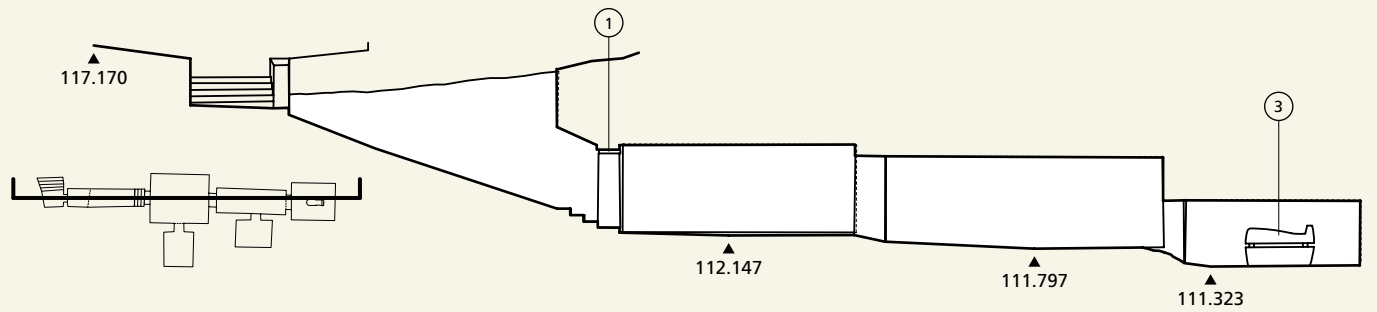
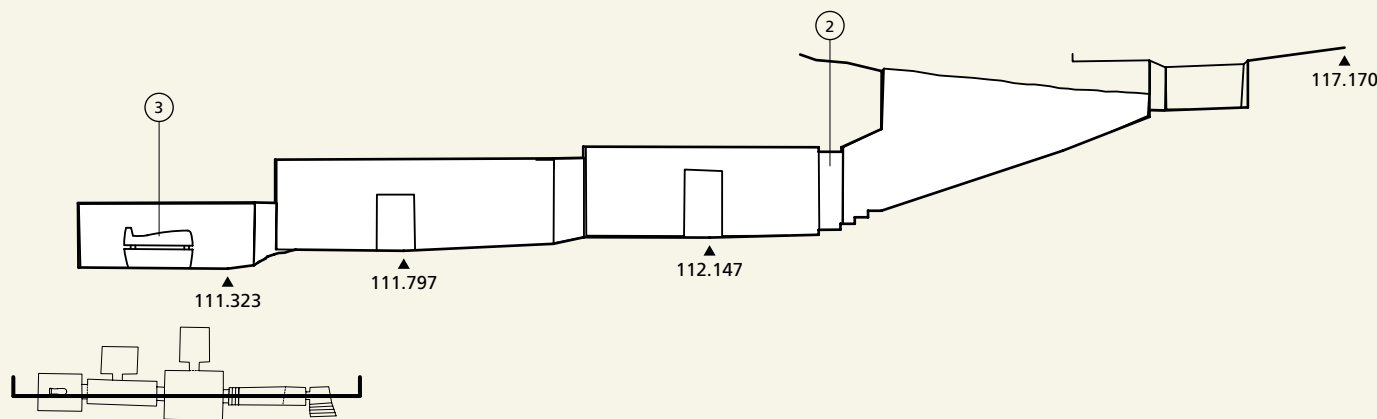
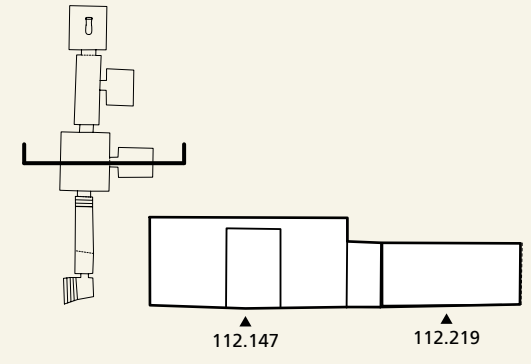
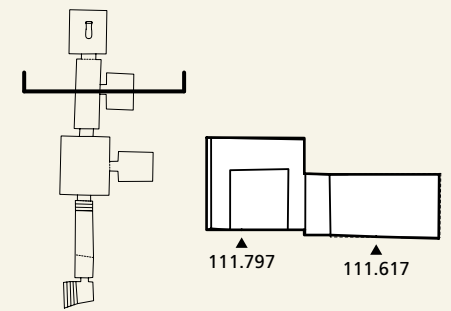
| 1 | Door jamb has slot cut at top for a lintel beam; jamb is mostly reconstructed concrete. |
| 2 | Door jamb is reconstructed concrete. There was likely a slot cut at the top for a lintel beam, but it is now filled with concrete. |
| 3 | Position and dimensions of sarcophagus approximate. |
