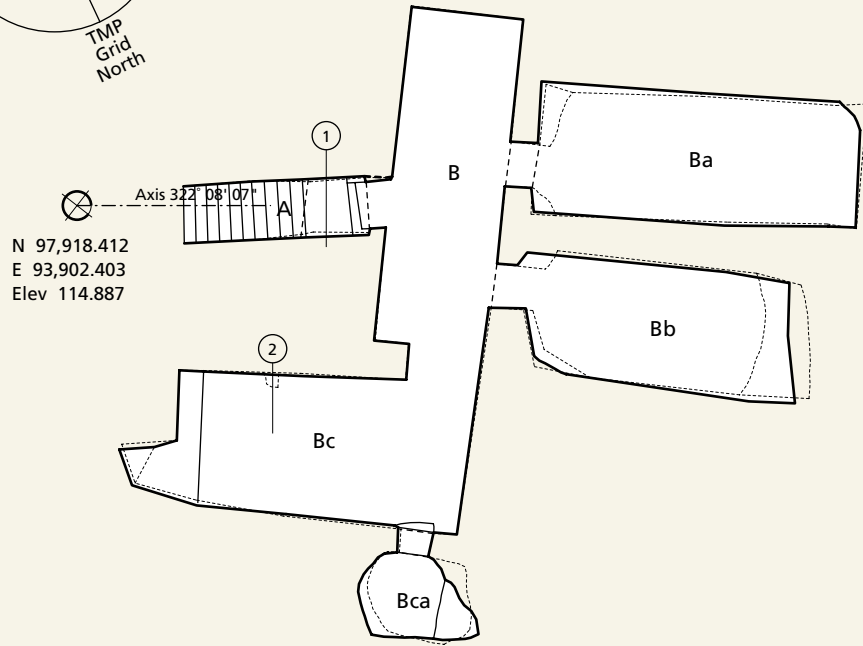
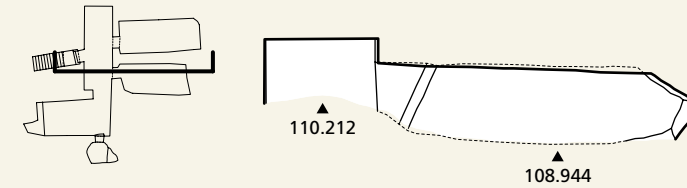
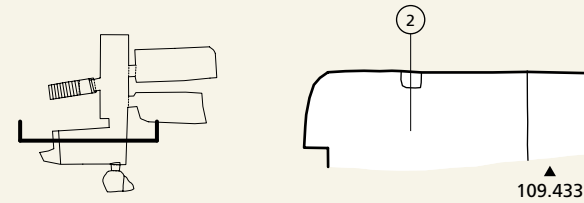
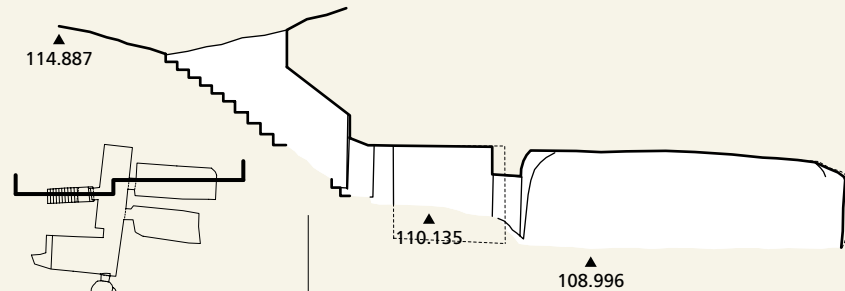
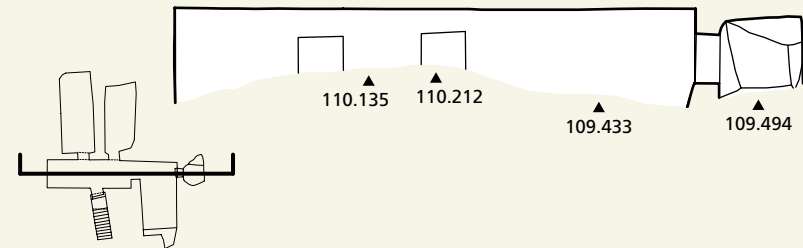
| 1 | Steps partly covered by debris; dimensions approximate. |
| 2 | Protrusion at ceiling, possibly remains of door jamb; dimensions approximate. |
