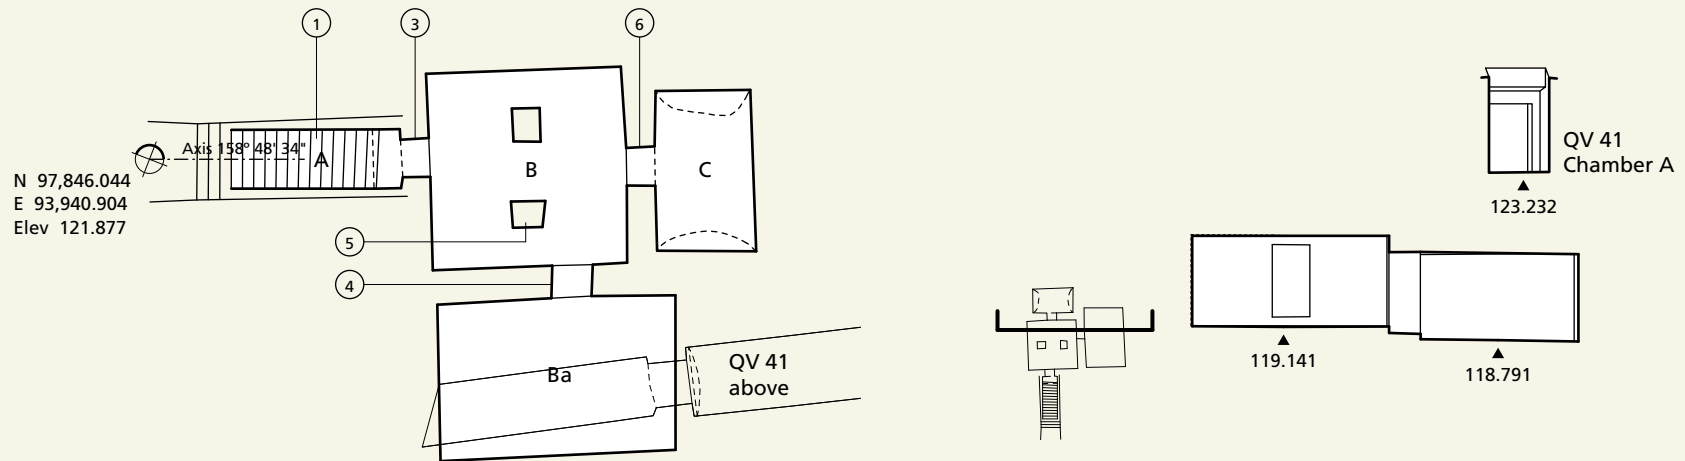
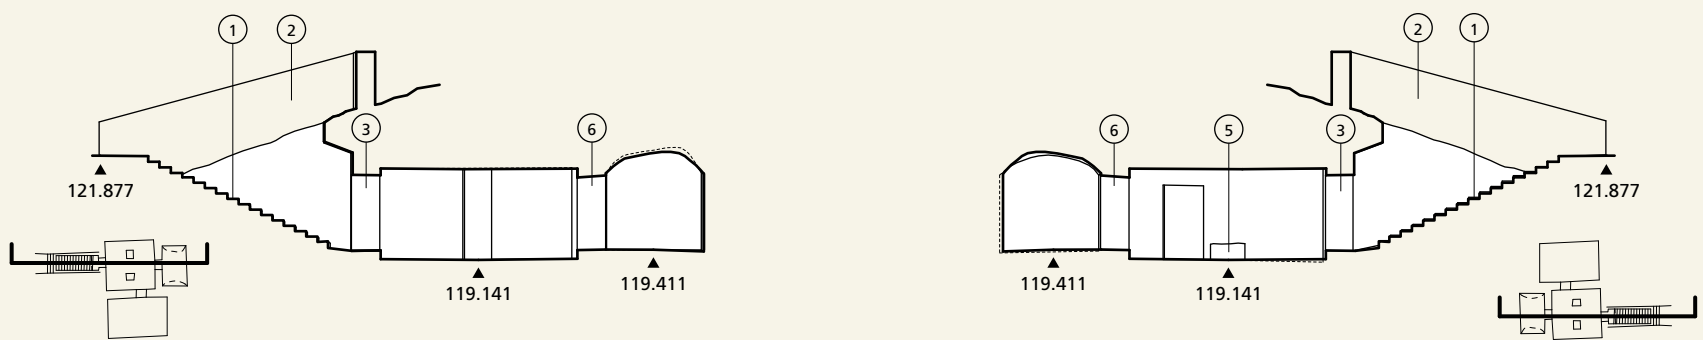
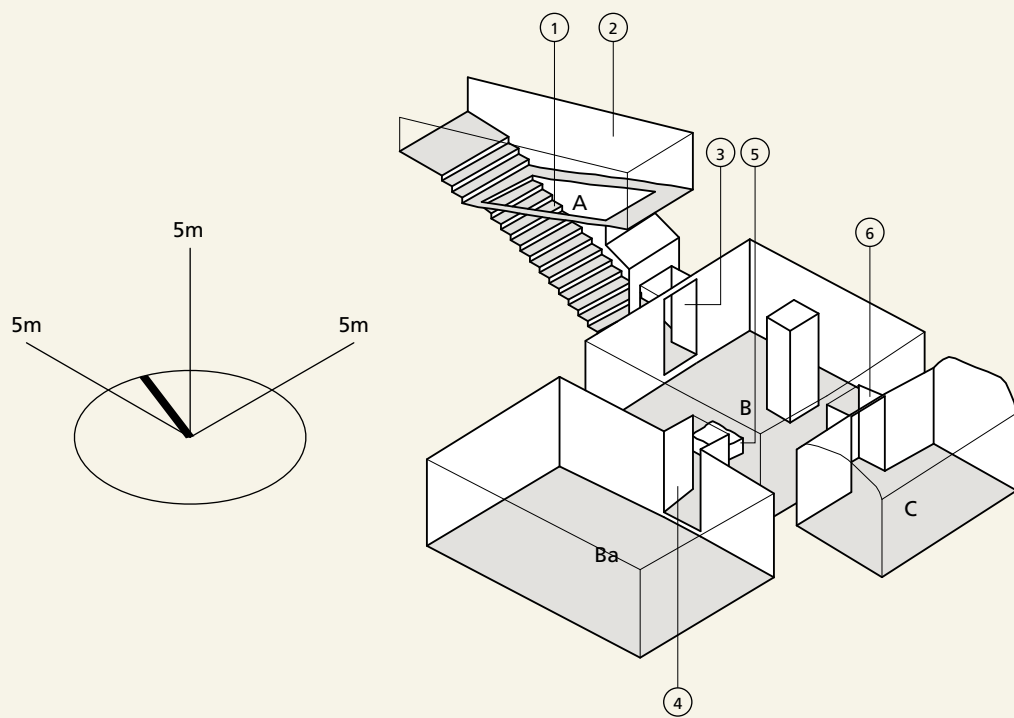
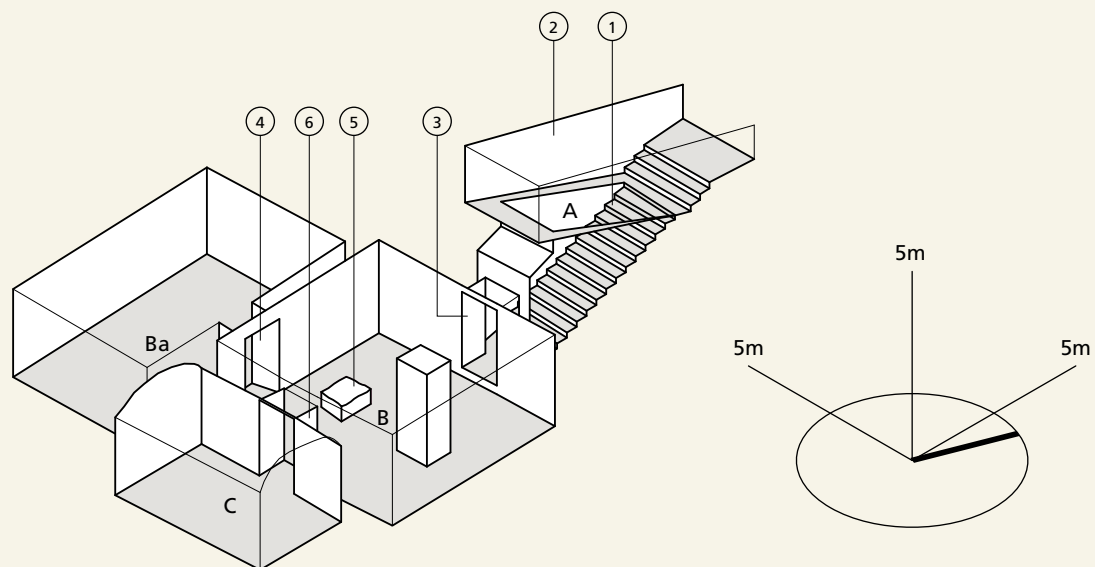
NOTES

| 1 | Modern steps; no evidence of original steps. |
| 2 | Modern retaining wall. |
| 3 | Both door jambs reconstructed. |
| 4 | Door jamb reconstructed. |
| 5 | Pillar damaged and partially reconstructed. |
| 6 | Lintel and both door jambs reconstructed. |
