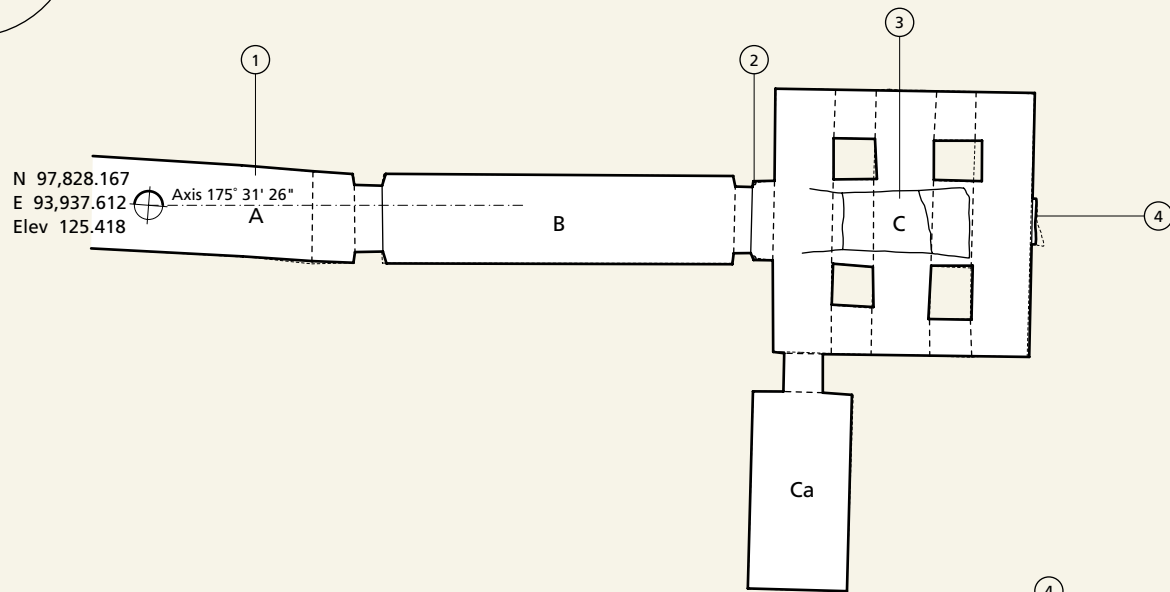
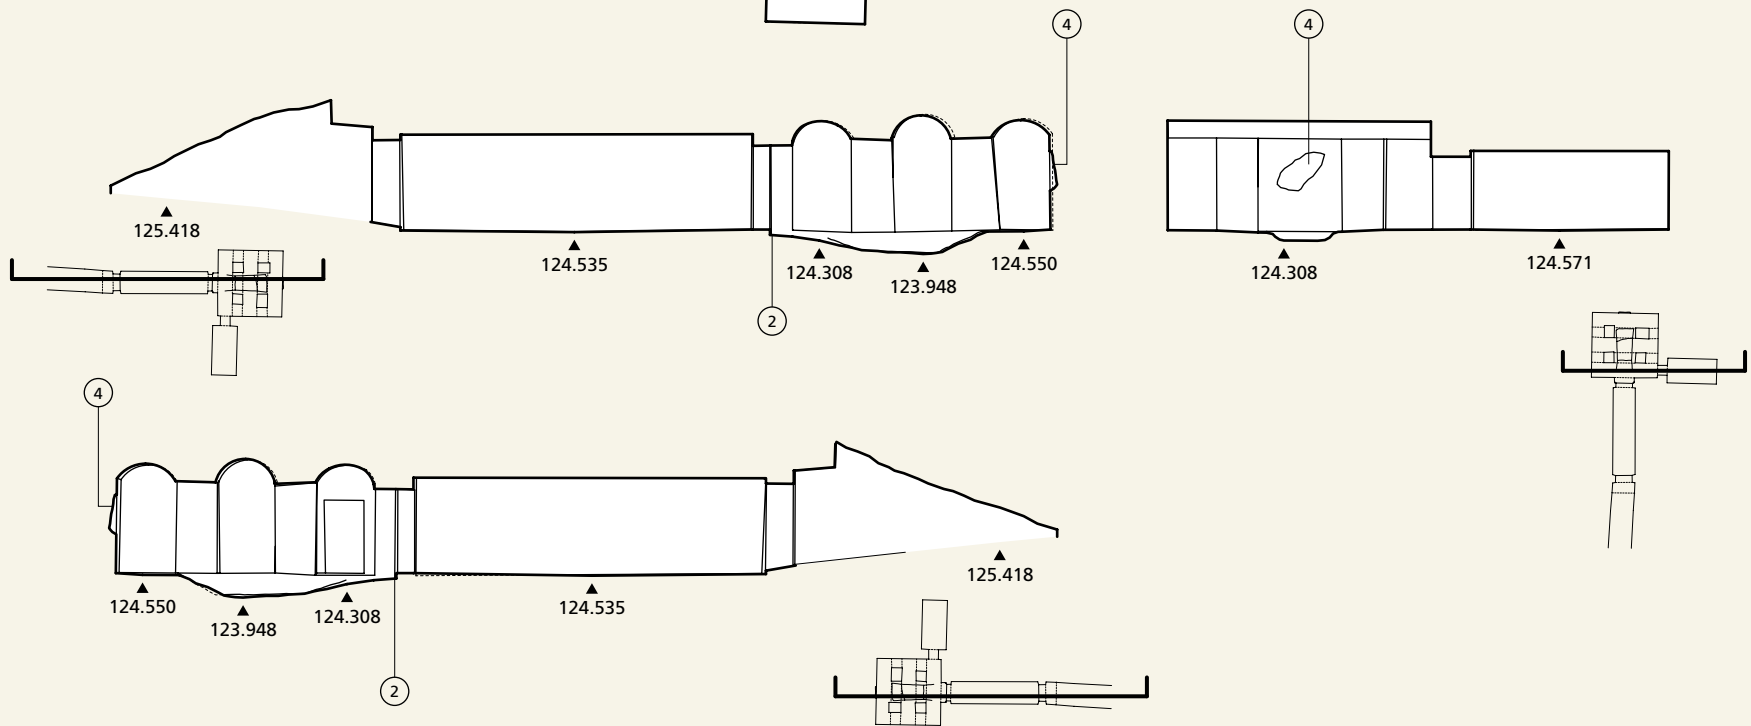
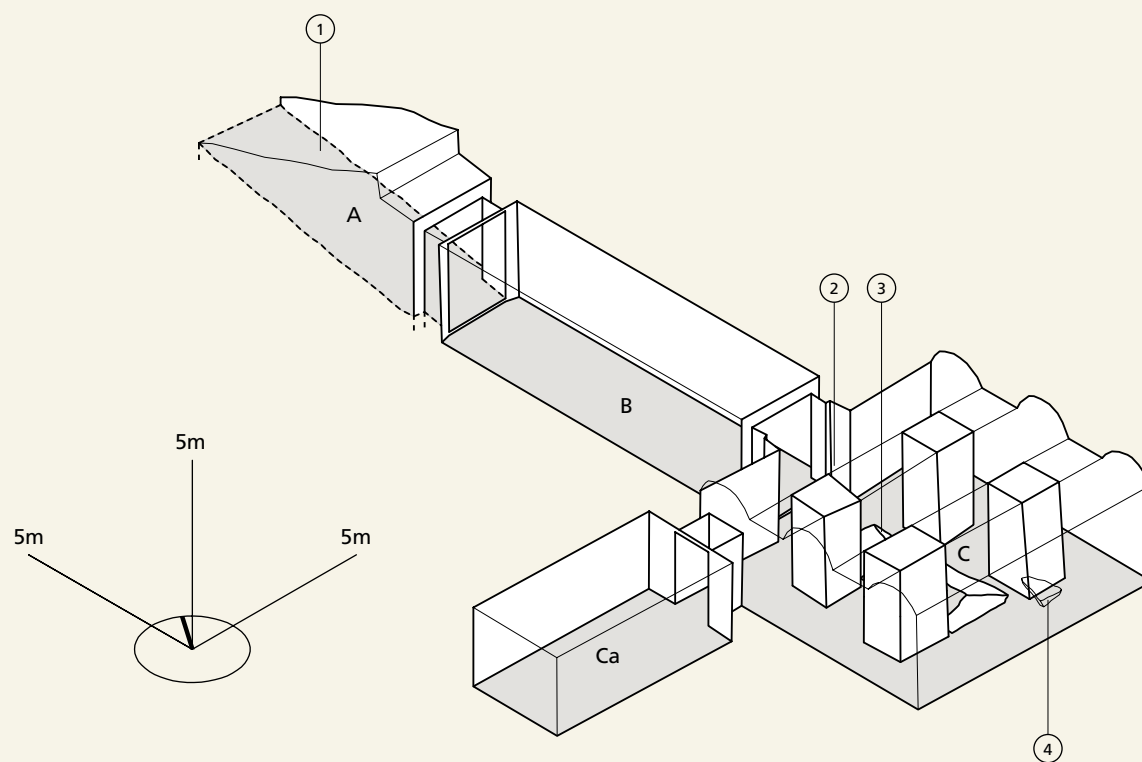
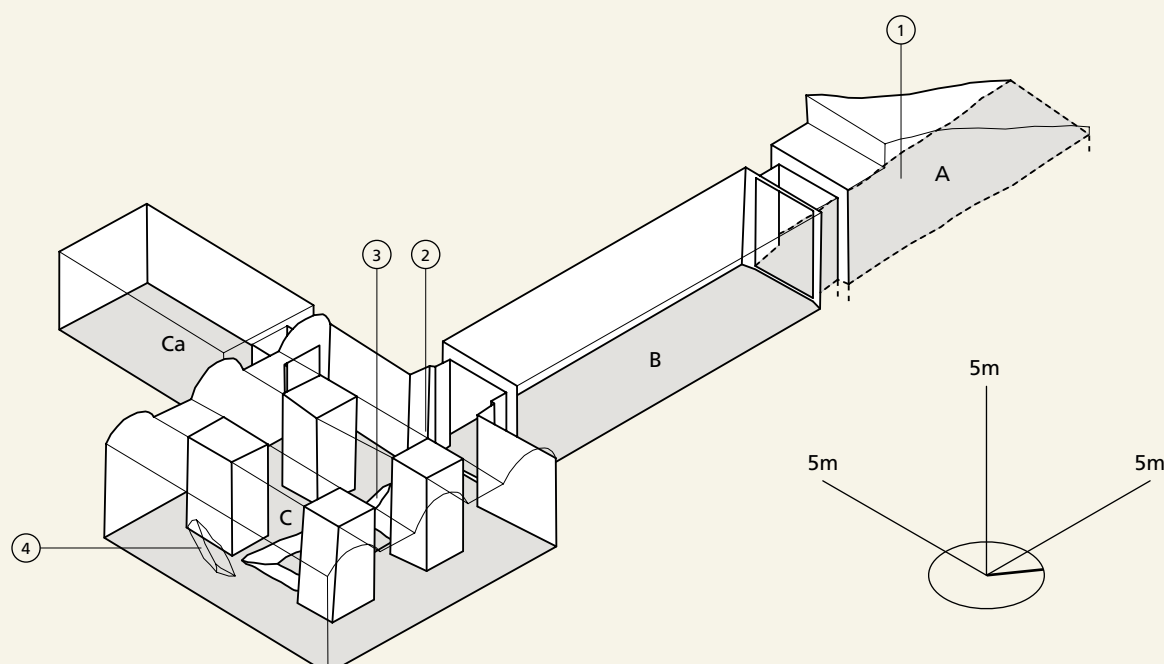
1	Entry ramp covered with rubble.
2	Post-holes in floor on both sides of doorway.
3	Roughly-cut pit in floor.
4	Roughly-cut niche in rear wall of chamber C; possibly of the early Christian period.
